CITY OF HUNTSVILLE VISITOR CENTER EXPANSION

Facility Assessment
October 30, 2015

PGAL

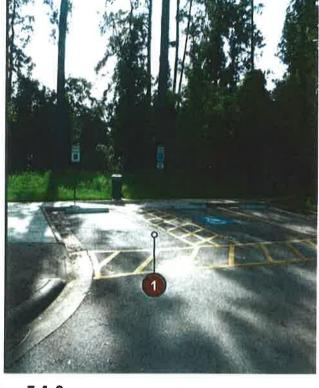
Figure 7-1-2

- CONDITION: Parking not ADA compliant REPAIR: Provide compliant parking spaces
- CONDITION: Non-code compliant handrail.

REPAIR: Replace with code compliant handrail.
- CONDITION: Site furniture not matching.

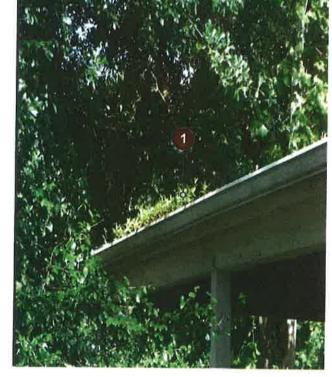
Figure 7-1-9

- CONDITION: Plant growing in rain gutter.
 REPAIR: Periodic maintenance cleaning of gutters.
- **CONDITION:** Roof support rotting due to roof leak. **REPAIR:** Repair roof leak and replace roof support.
- CONDITION: Water mark indication of roof leak to interior of building.

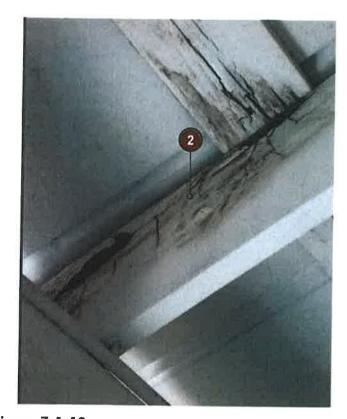
Figure 7-1-10

The guard rail supports are not properly attached to the wood deck and in some areas have rotted wood that needs to be replaced. The entire railing system needs to be replaced.

CONDITION: Guardrail support not properly anchored, allowing excessive flex and in some cases are rotting.

REPAIR: Remove and replace support posts with proper attachment to deck and provide gap between wood posts and deck to prevent water absorption to bottom of post.

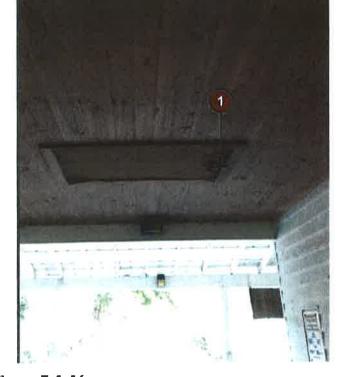
Figure 7-1-16

- CONDITION: Attic hatch deteriorating.
 REPAIR: Replace.
- CONDITION: No weep hole at brick veneer wall, causing efflorescent.

REPAIR: Provide weep holes and/or building sealing.
- CONDITION: Wood trim detached from wall REPAIR: Repair or replace.
- CONDITION: Crack in concrete floor, REPAIR: Repair with epoxy.
- CONDITION: Incandescent lights required constant replacement.

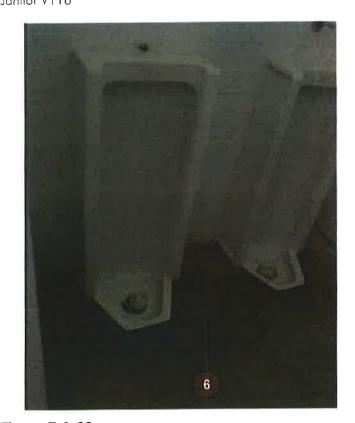
Figure 7-1-29 Men's Room V115

- CONDITION: Toilet room floor stained.

REPAIR: Clean and coat with water repellent coating or tile. Provide weep holes and / or seal building.
- CONDITION: Sink pipes not covered per ADA. REPAIR: Provide pipe covers.
- CONDITION: Hand dryer protrudes more than 4" from wall in path of travel not ADA compliant.
